Manhole Inspection Summary

Manhole # S35S__073MH

Insp Date: **7/9/09 3:14 PM**

Location Address: **1402 Patapsco St**

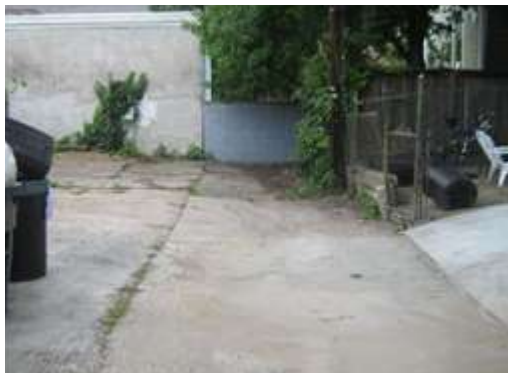
Location View

alley behind residence

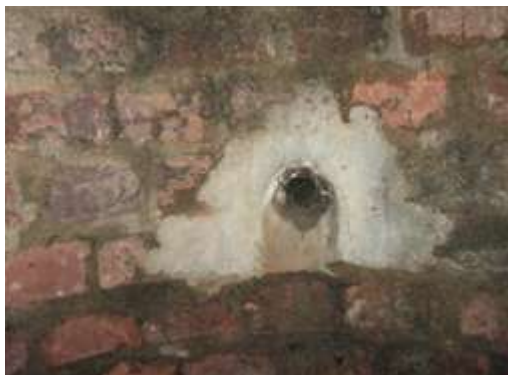
Miscellaneous

abandoned flushing line @ 6

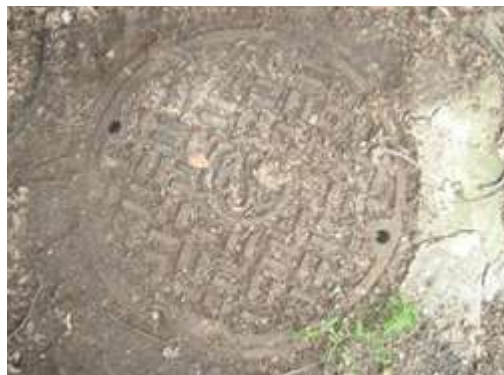
Miscellaneous

MH cover

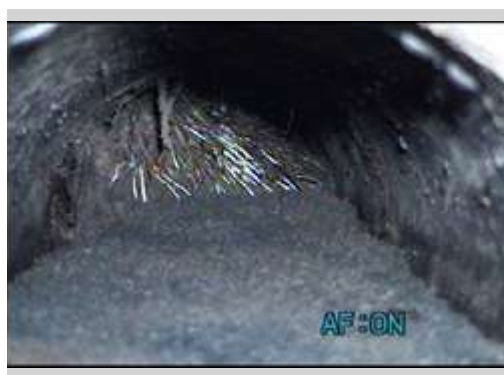
Defect 3

Condition: ☐ Sound ☐ Cracked ☒ **Root Intrusion** ☐ Deteriorated ☐ Leaks ☒ **Debris**

roots downstream from pipe connection
O-12

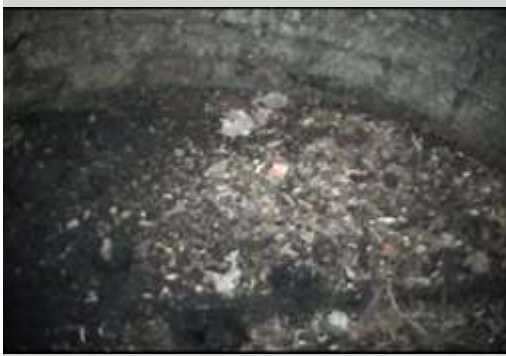
Defect 5

roots & sediement in channel

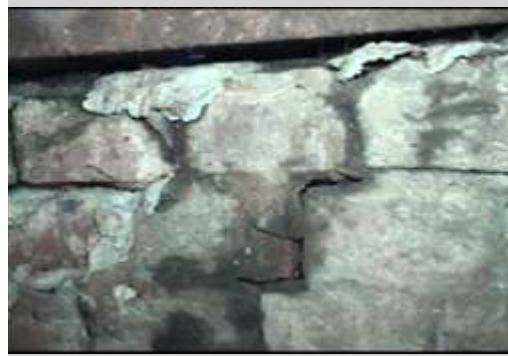
Defect 4

Condition: ☐ Sound ☒ **Cracked** ☐ Root Intrusion ☐ Loose Brick ☐ Deteriorated

crack in chimney wall

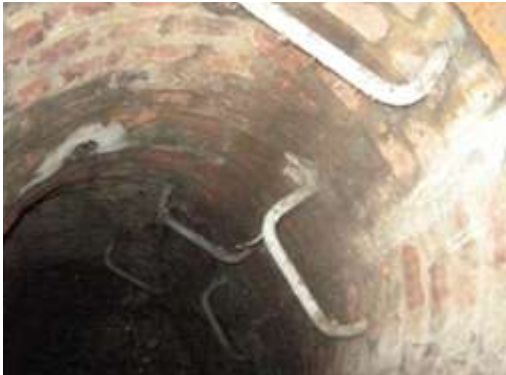
Defect 2

Infiltration: ☐ None ☐ Joint ☐ Cracks ☐ Mortar ☐ Roots ☒ **Wall**

Steps Count: **5** Missing: **0** ☒ **Corroded**

evidence of infiltraion corbel wall;
corroded steps

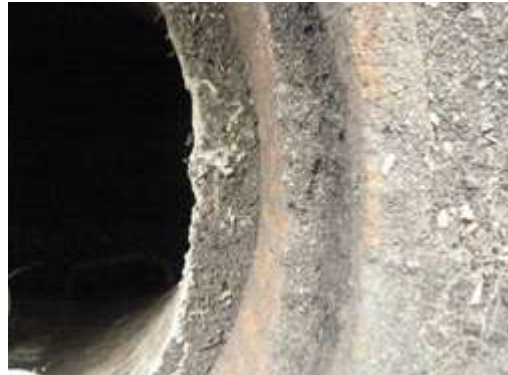
Defect 1

Frame Offset: **2** (in.) Condition: ☒ Sound ☐ Cracked ☐ Leaks

2" frame offset

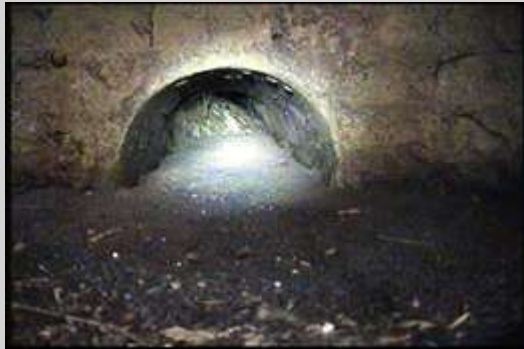
12 O'Clock Outflow

8 in. Circular Gravity Sewer
Pipe Out @ 12 O'Clock

Infiltration: **None** Pipe Seal Cond: **Sound**
